January 4, 2023

3008

**Geotechnical Infiltration Testing Letter Report
Proposed Clackamas County Fairground Infiltration Facility
Canby, Oregon**

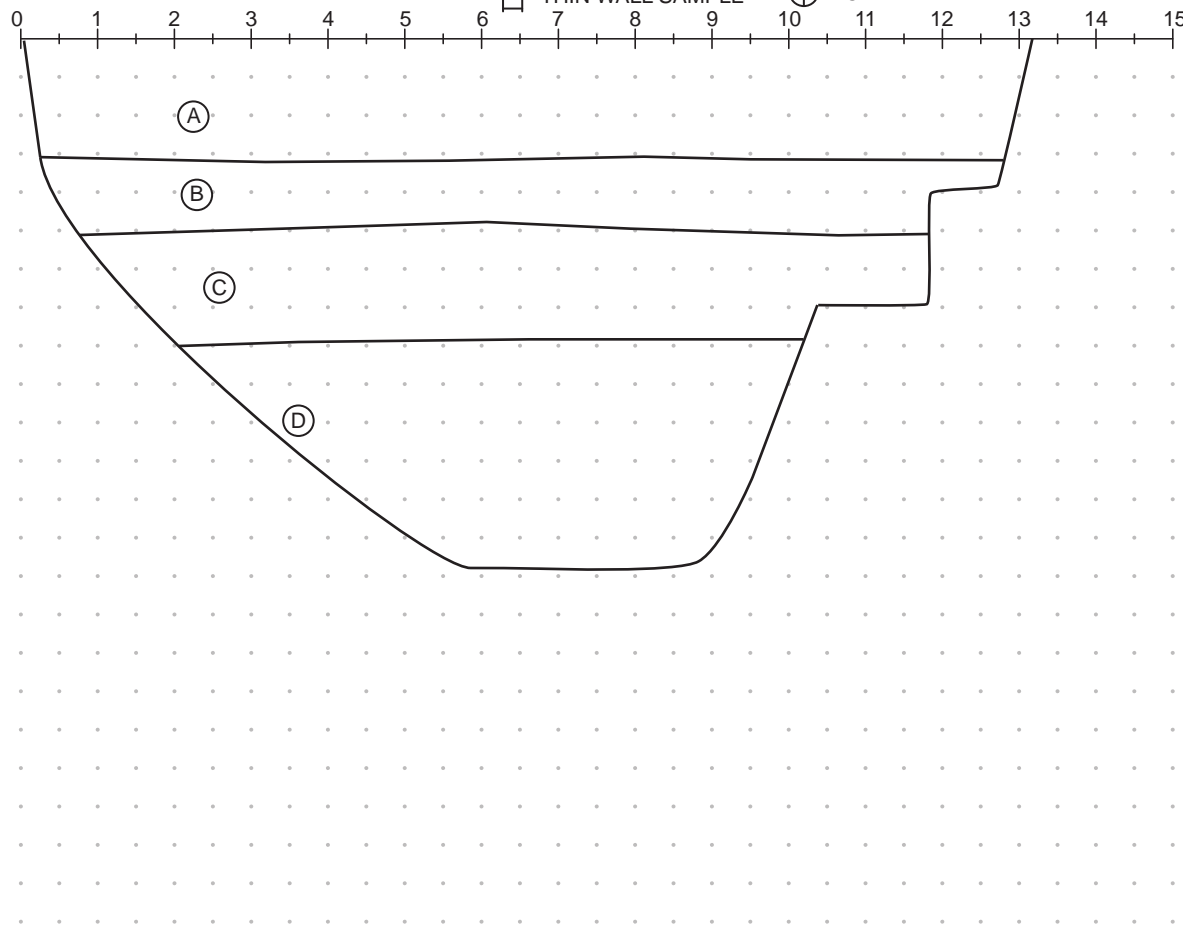
3

(A) MEDIUM STIFF, dark brown, slightly sandy SILT; sand is medium to fine, rounded, light brown to gray; moist, non-plastic to low plasticity; numerous organics (fine roots)

(B) MEDIUM STIFF, dark brown, slightly sandy SILT; trace clay; moist, low plasticity; becomes lighter brown with depth to approximately 3.7'; numerous organics (roots)

(C) STIFF, dark brown, slightly sandy to sandy SILT; numerous sub-rounded, brown to gray, gravels and cobbles; trace clay; moist, non-plastic

(D) LOOSE to MEDIUM DENSE, gray to brown, very silty, sandy GRAVEL; numerous cobbles and boulders up to approximately 2.0 feet in maximum dimension; gravel is fine to coarse; moist, non-plastic

Note: No samples collected. Infiltration test performed approximately 6.9 feet below ground surface.

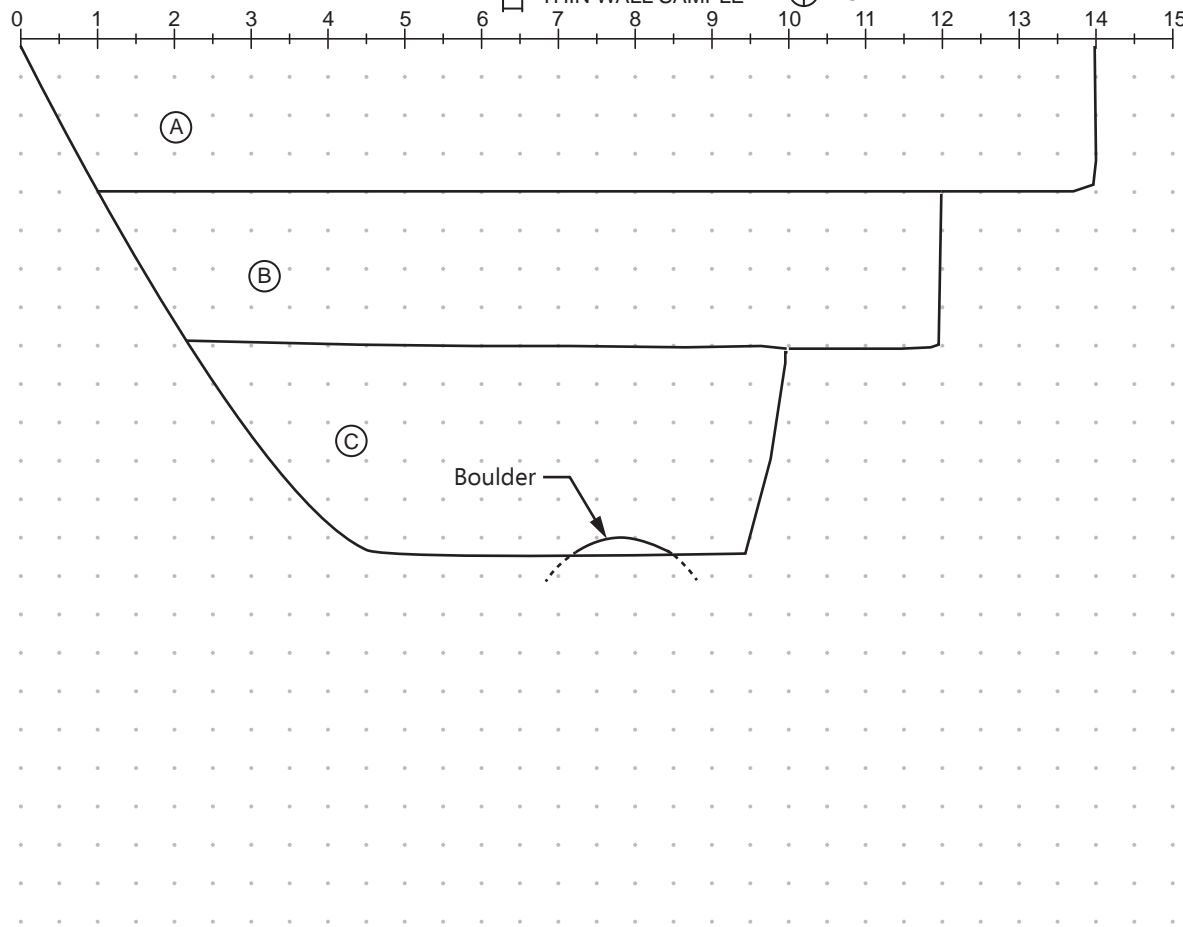
4

(A) MEDIUM STIFF, dark brown, slightly sandy SILT; sand is medium to fine, rounded, light brown to gray; moist, non-plastic to low plasticity; numerous organics (fine roots)

(B) MEDIUM STIFF, dark brown, slightly sandy SILT; trace clay; moist, low plasticity; becomes lighter brown with depth to approximately 3.7'; numerous organics (roots)

(C) LOOSE to MEDIUM DENSE, light brown to gray, silty SAND; numerous subrounded, light gray to brown, gravels and cobbles; scattered boulders (approximately 3 feet maximum dimension) encountered at 6.5' bgs; sand is medium coarse; non-plastic; occasional woody roots up to approximately 0.5"

Note: No samples collected. Infiltration test performed approximately 6.7 feet below ground surface.
