VI. Stormwater Report

Storm Drainage Report Hope Village Campus Modifications

J.O. SGL 18-073B

Hope Village Original Campus, Site Modifications:

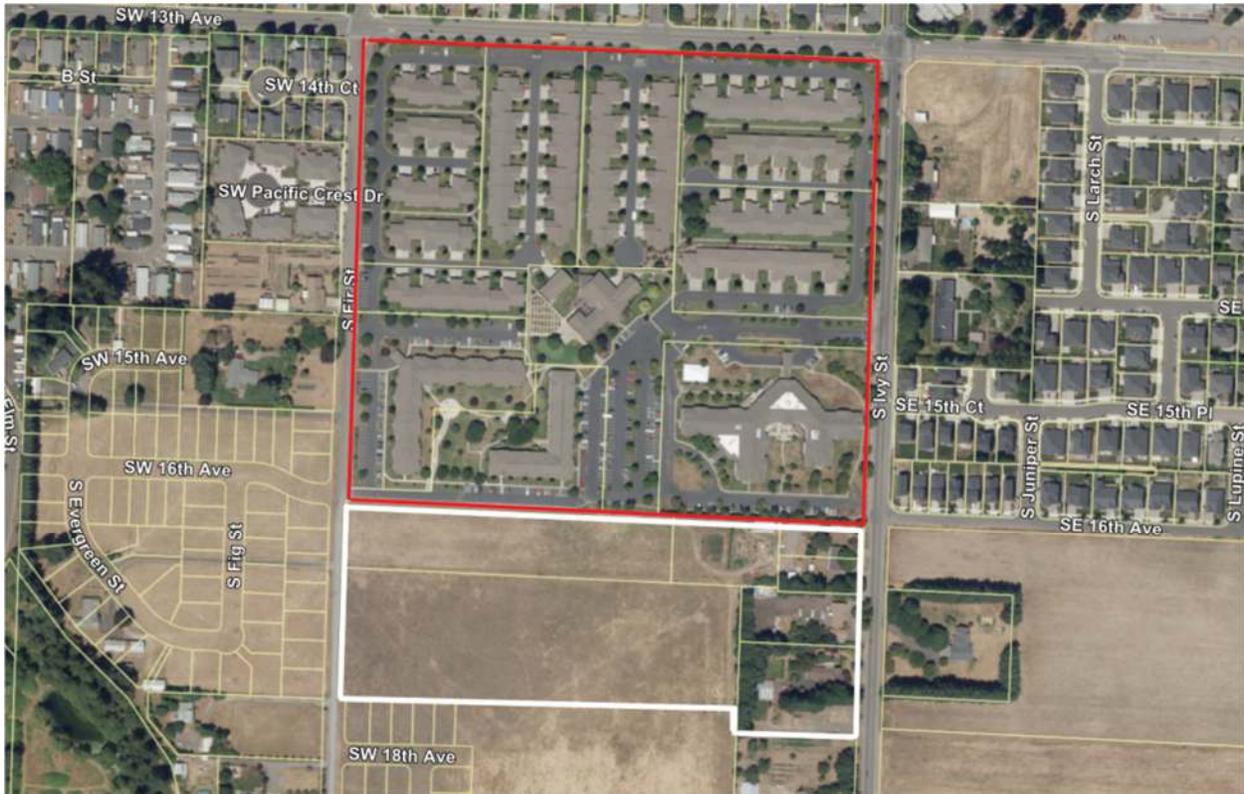
The Hope Village campus is in south Canby and is bounded between SW 13th and SW 18th Avenues to the north and south, and S Fir and S Ivy Streets to the west and east. In the image below, the original Hope Village campus is noted in red and the South Campus portion of Hope Village is noted in white.

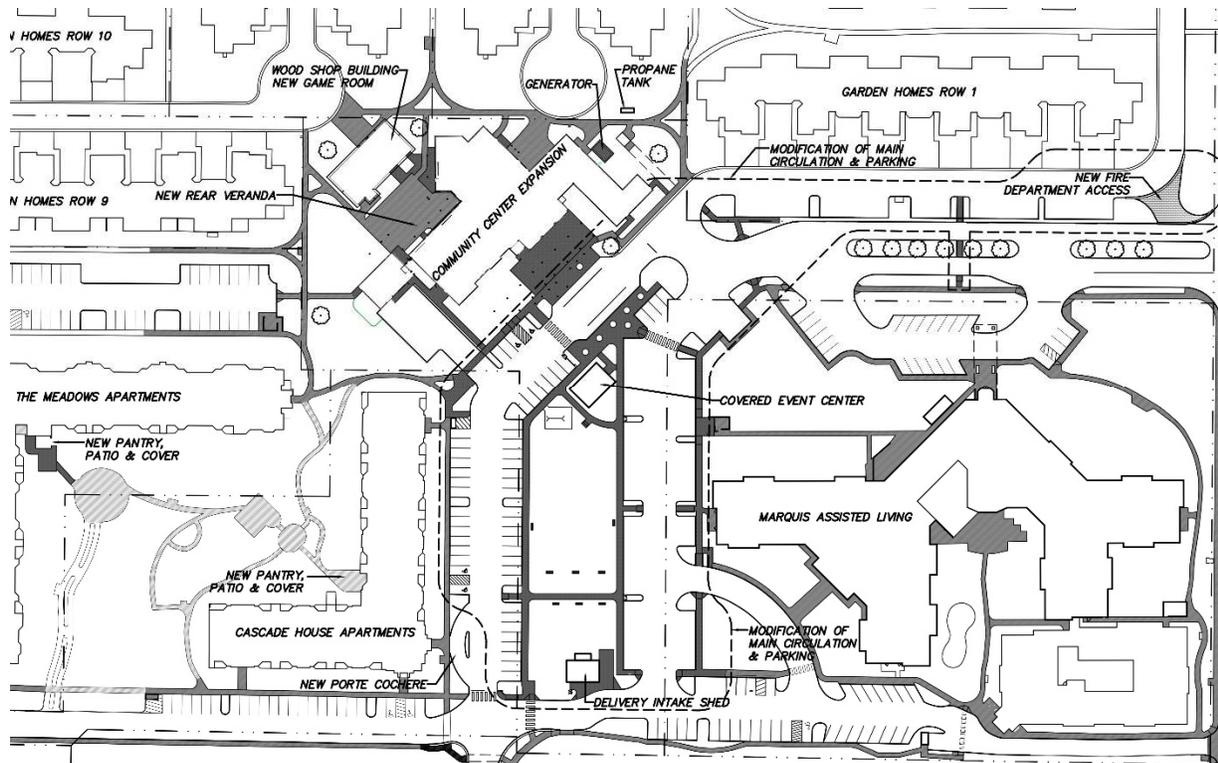
The proposed improvements will occur within the original portion of the Hope Village campus. Projects will include a minor covered patio addition to the rear of The Meadows apartment building, a minor covered patio addition to the rear of the Cascade House apartment building and the addition of a Porte Cochere on the front, expansion of the Community Center, creation of an Emergency Fire access near the S Ivy Street entrance, and a reimagining of the central parking area located between Cascade House, Marquis, the South Campus, and the Community Center. A map of the site improvements is on the following page:

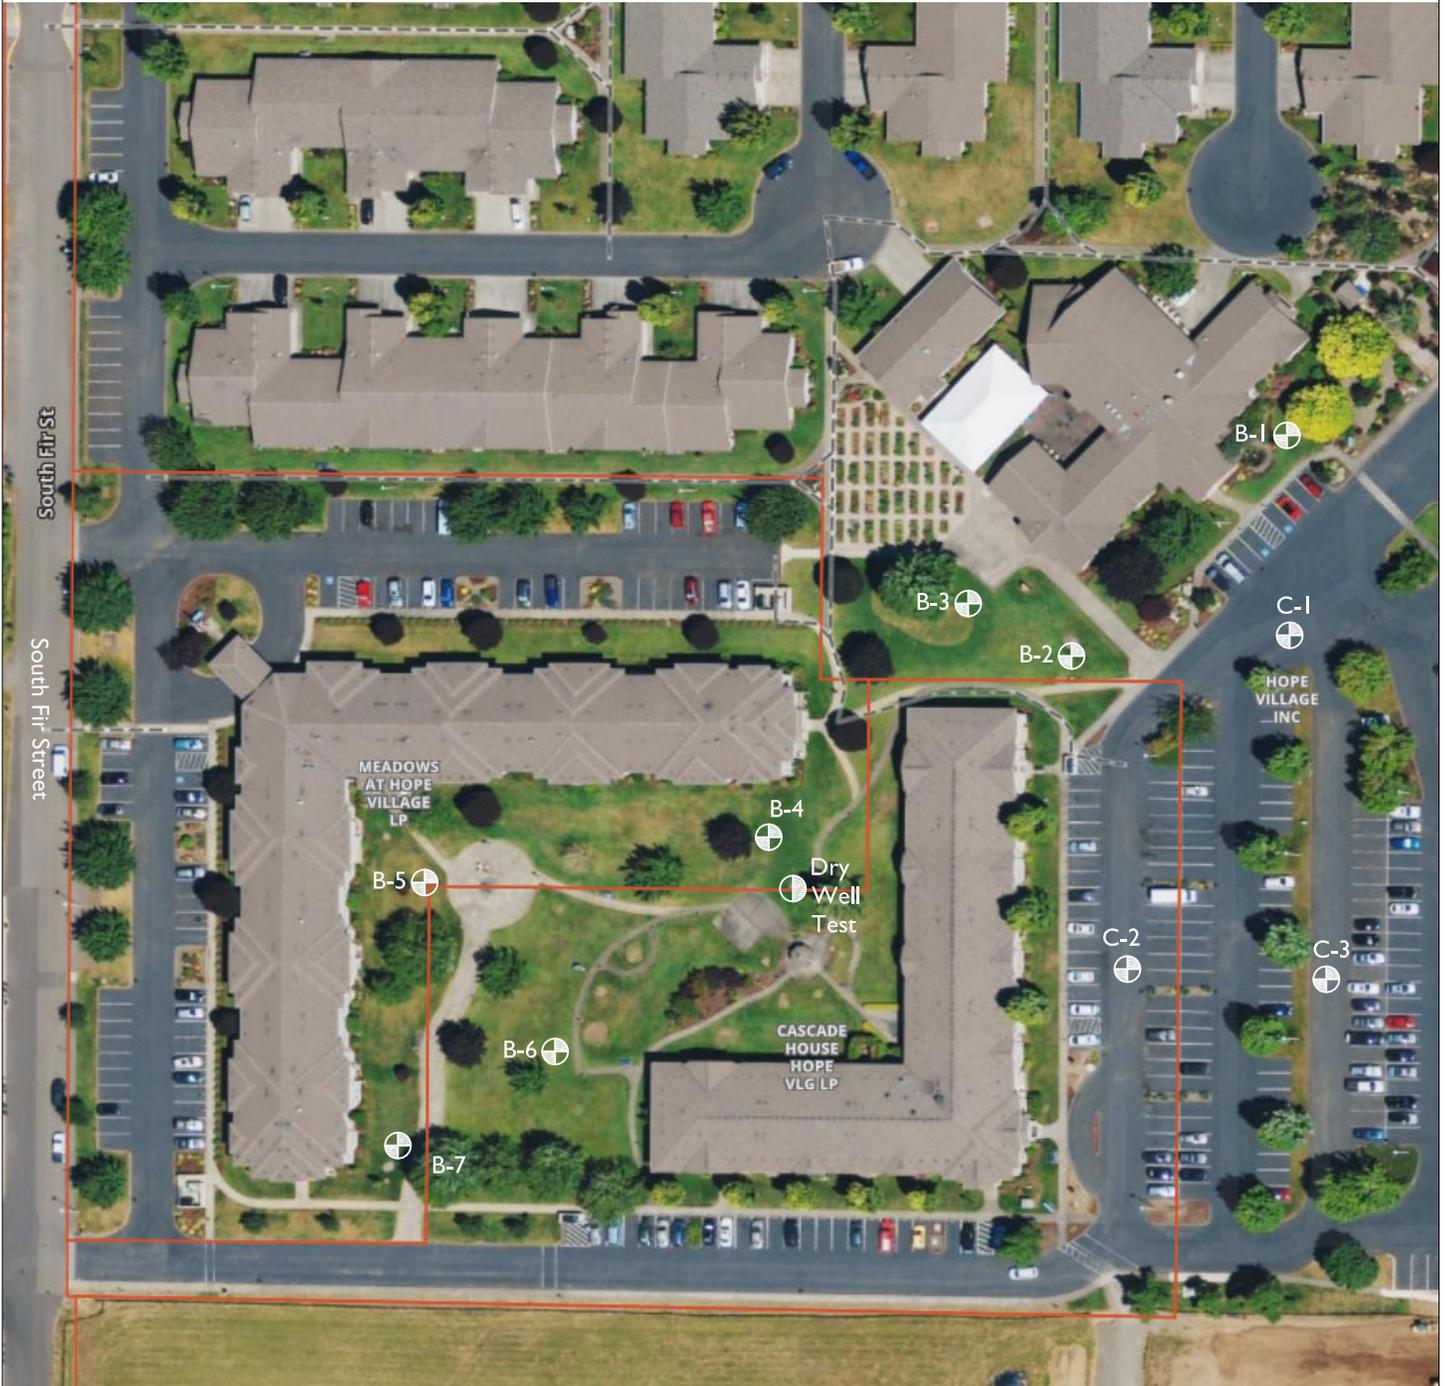
Attachments – Site Plan, Guidelines for Classification of Soil, Boring Logs, Moisture Contents

NOT TO SCALE

BASE PHOTO FROM ONXMAPS

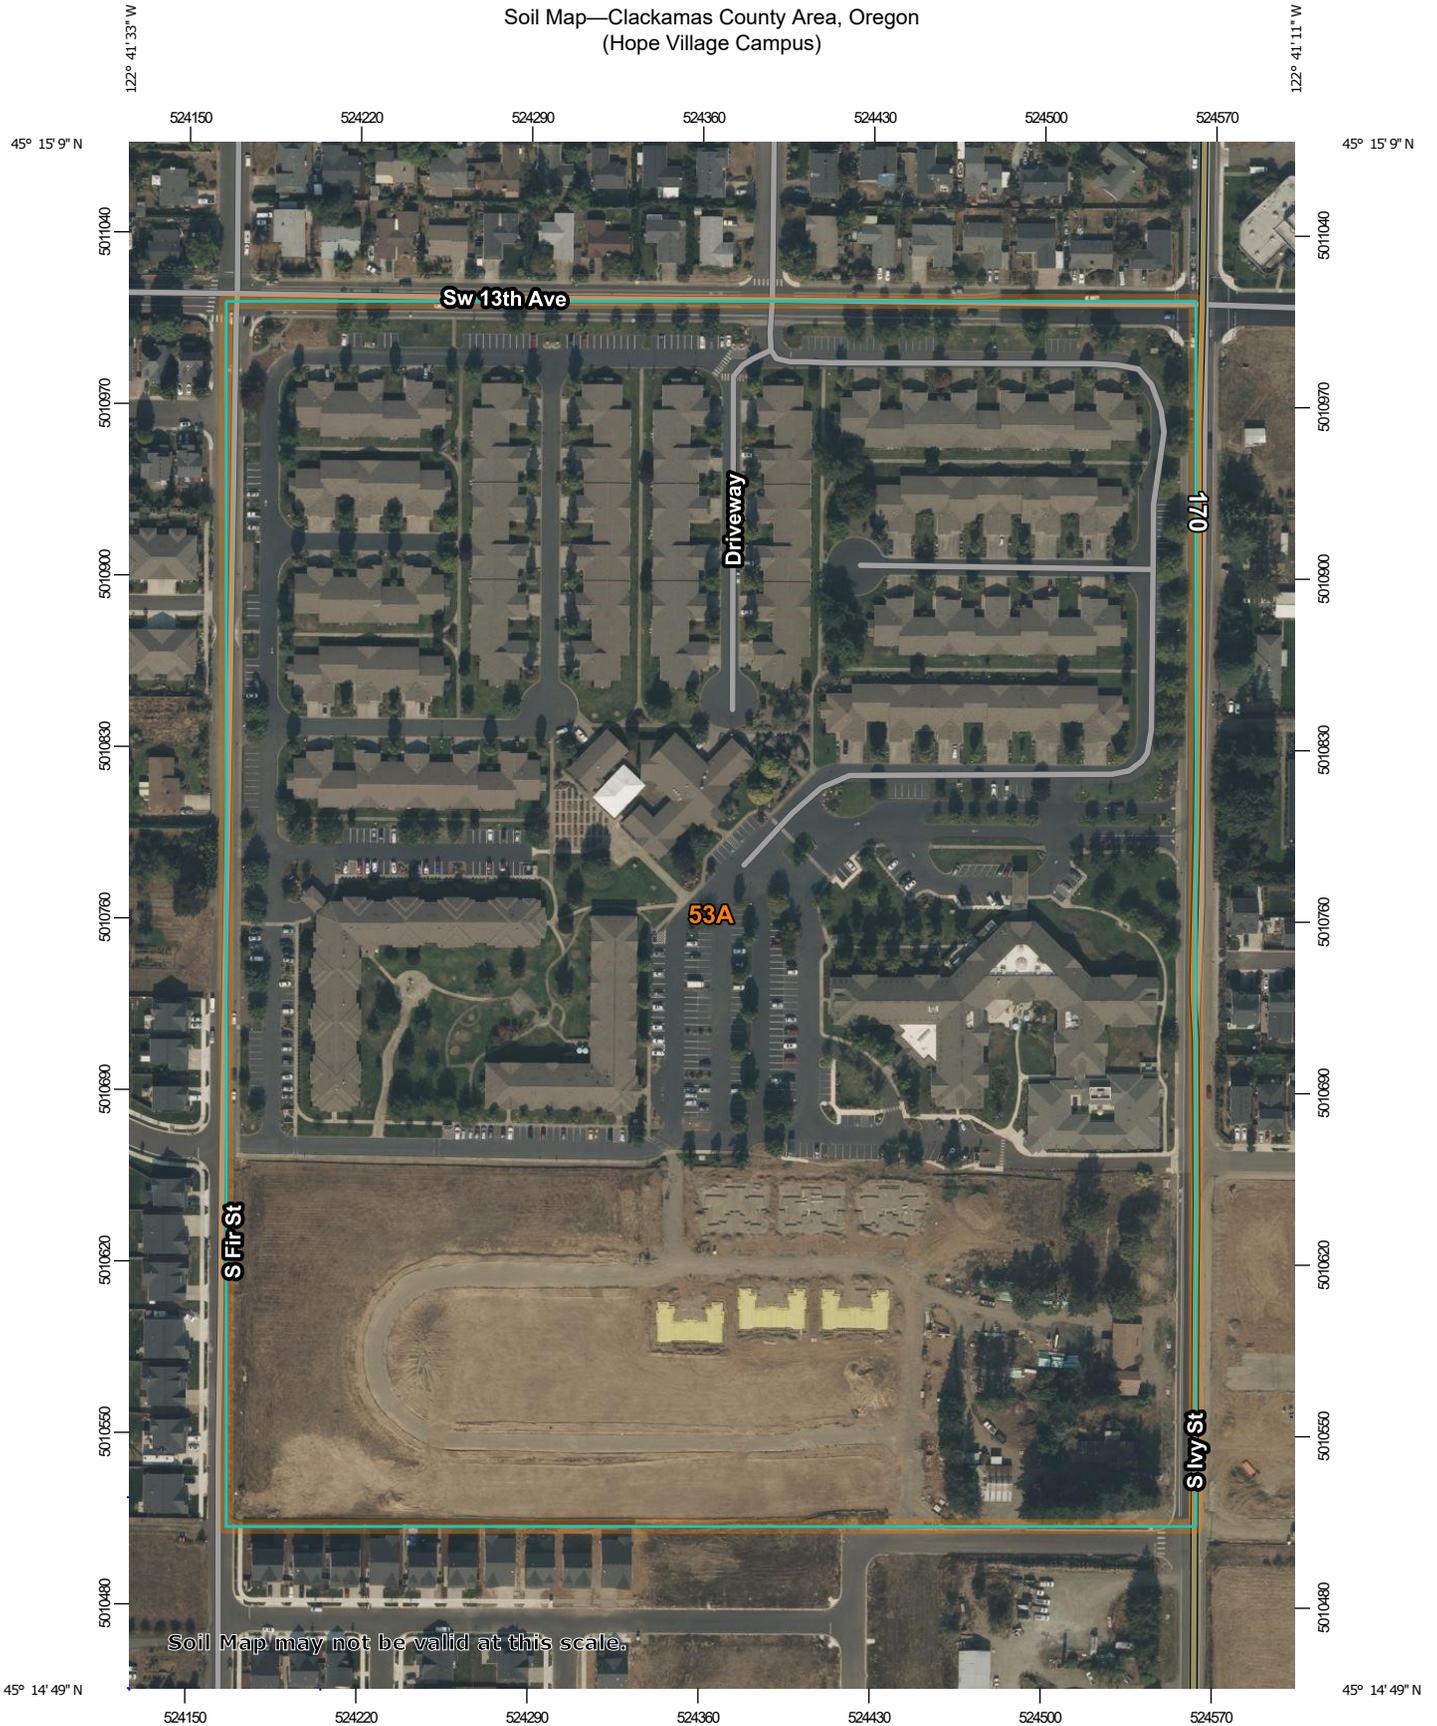
Soil Map—Clackamas County Area, Oregon
(Hope Village Campus)

Map Scale: 1:3,070 if printed on A portrait (8.5" x 11") sheet.

Per the Web Soil Survey, the site has Latourell Loam soils, 53A, hydrologic soil group B. The CN number for per Table 3.5.2B SCS Western Washington Runoff Curve Numbers, King County Washington Surface Water Design Manual, 11/92, is noted below:
