Molalla Forest Road, Traverso Section: Final Development Plan

Prepared for City of Canby

Parametrix, 2021. Molalla Forest Road, Traverso Section: Development Plan. Prepared by Parametrix, Portland, Oregon. April 2021.

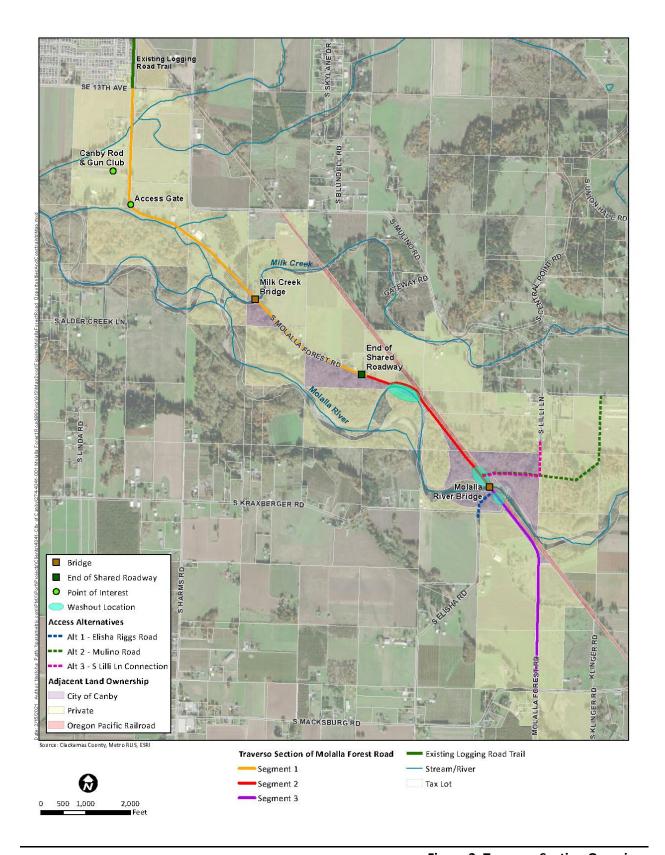
Figure 3. Traverso Section Overview

Figure 3 shows the Traverso Section major features and segmentation used to develop trail design concepts. As of late 2020, the Traverso Section of the MFR consisted of the original asphalt-paved roadway in varying degrees of disrepair. Two bridge structures exist along the MFR – the Milk Creek Bridge and the Molalla River Bridge. The following provides a general description of existing conditions in the Traverso Section.

This Development Plan includes trail design concepts for the three segments of the Traverso Section (Figure 3). Trail design concepts were developed with consideration of the following:

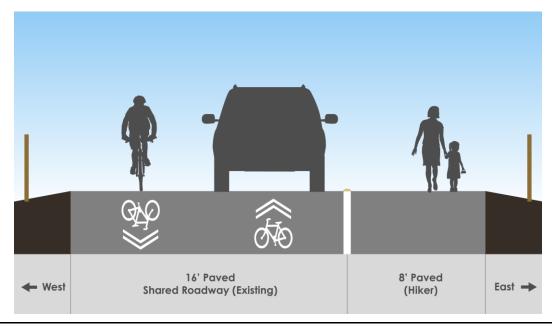
Figure 4. Segment 1 Paved Multiuse Trail Alternative

Figure 4 and Figure 5 show alternative trail cross sections for Segment 1. Further design work and outreach is needed prior to determining the preferred trail cross section. The Traverso property deed requires that any potential trail be on the east side of the MFR property in the vicinity of the Canby Rod and Gun Club. Additionally, Segment 1 is critical to accessing homes, farms, and businesses along this section of the MFR. The road is used for accessing properties by car, for deliveries (including large trucks to the Canby Rod and Gun Club), and for farm using the road. Therefore, the alternative trail cross sections all propose maintaining the existing roadway and augmenting the corridor with trail facilities on the east side of the corridor, until the trail passes to the southeast of the gun club, where it would cross the road and continue on the west side of the roadway.

Notably, it is proposed that cyclists ride on the road in this section, with sharrows (pavement markings as shown in Figure 4) indicating that cyclists are likely to be present. Because the roadway experiences low vehicle traffic, cyclist use of the main road should function well. Public outreach indicated a slight preference for separating cyclists from pedestrian traffic as shown in Figure 4.

The trail concept for this segment envisions widening of the existing paved surface. This widening would likely trigger stormwater conveyance and potentially water quality treatment requirements that would be incorporated into the design and are considered in the cost estimates in Section 4. Additionally, construction of the trail would require retaining structures in some places and the potential for culvert extensions to accommodate the wider cross section; these improvements are constructable, but do increase the cost of the proposal.

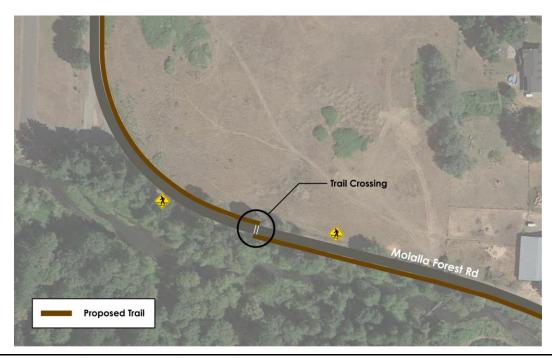
Figure 6. Proposed Trail Crossing on south end of Segment 1

To accommodate the previously mentioned deed condition that the trail be on the east side of the MFR until it passes beyond the gun club property, a crossing could be built where the trail crosses to the other side of the MFR. The trail would continue on this side of the corridor until its terminus at Macksburg Road. Figure 6 shows the proposed crossing location.

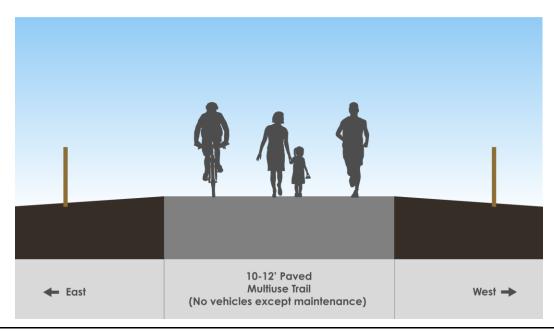
Figure 7. Segment 2 Preferred Trail Cross Section

This section includes the most complex design considerations in the corridor related to the washout and river crossing. At the north end of Segment 2, starting at the end of the shared roadway, the trail is not used for private property access. The roadbed in Segment 2 is deteriorated and overgrown by brush, and is missing altogether in the 1996 washout area. Clearing the brush from this area and restoring good sight lines would allow for more "eyes on the trail" to deter unwanted activities. The preferred trail cross section accommodates a multiuse trail that would be exclusive to pedestrians, cyclists, and useable by maintenance or emergency vehicles as needed (see Figure 7).

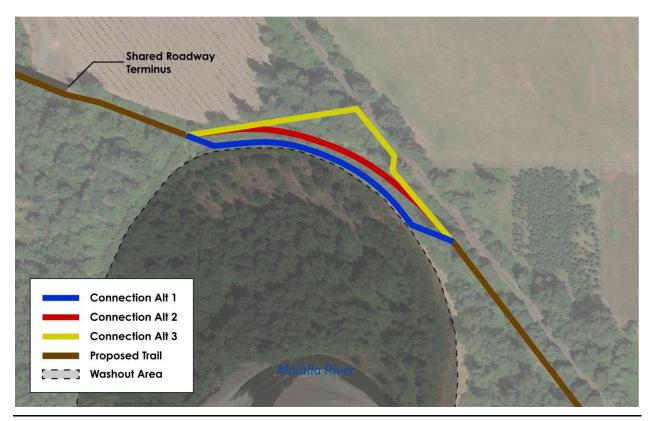
Figure 8. Connection Alternatives for Rebuilding Washed-Out MFR

The Molalla River Bridge structure is intact, and field visits indicated that it is in useable condition, though further engineering investigation is needed. Table 1 describes different alternatives for constructing a trail in the washout area and connecting to the existing bridge structure. Figure 8 shows the different alignments of these alternatives.

Alt. No. ¹	Alternative Description	Pros/C	Likely Cost
1	Rebuild the trail along the original MFR alignment	 Would not require easements Requires significant infill, structural support, and grading 	\$\$\$
2	Reconstruct the MFR along the elevated stable ground adjacent to the railroad corridor (recommended approach)	 Requires an easement on private property with minimal impacts Lowest-cost solution 	\$
3	Rebuild the MFR along the railroad right of way	 Requires an easement from the railway; this may be difficult to obtain More difficult from a construction and permitting perspective 	\$\$

$^{{\}bf 1}$ Number refers to the alternative shown in Figure 8.

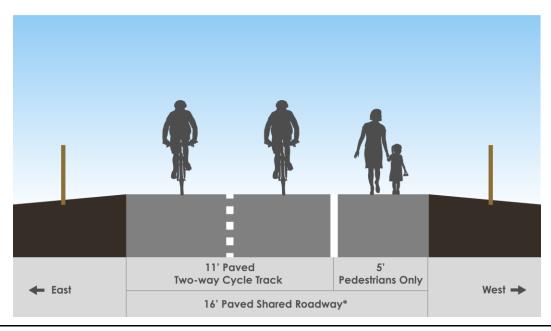
Figure 9. Segment 3 Trail Alternative

The trail concept for this segment widens the existing paved surface (see Figure 9). This widening would trigger stormwater conveyance and potentially water quality treatment requirements that would be incorporated into the design and are considered in the cost estimates in Section 4.

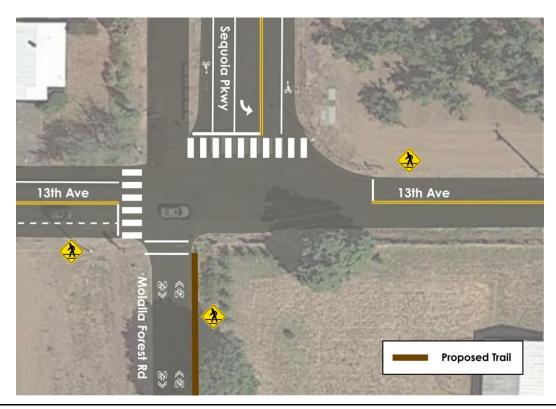
Figure 10. SE 13th Intersection Concepts

The intersection of SE 13th Avenue and Sequoia is an all-way stop-controlled intersection. Minor improvements to the intersection are needed to facilitate safe crossings for cyclists and pedestrians. Figure 10 shows conceptual intersection improvements. Additionally, signage is proposed to deter non-local traffic from using the road near this intersection.

The north end of the Traverso Section would connect directly to the existing shared-use path in the City of Canby at the intersection of SE 13th Avenue and Sequoia Parkway. No parking area or major trailhead access is proposed for this section because of this direct connection to the existing trail. Additionally, there is no obvious location for developing a trailhead or parking in the vicinity.

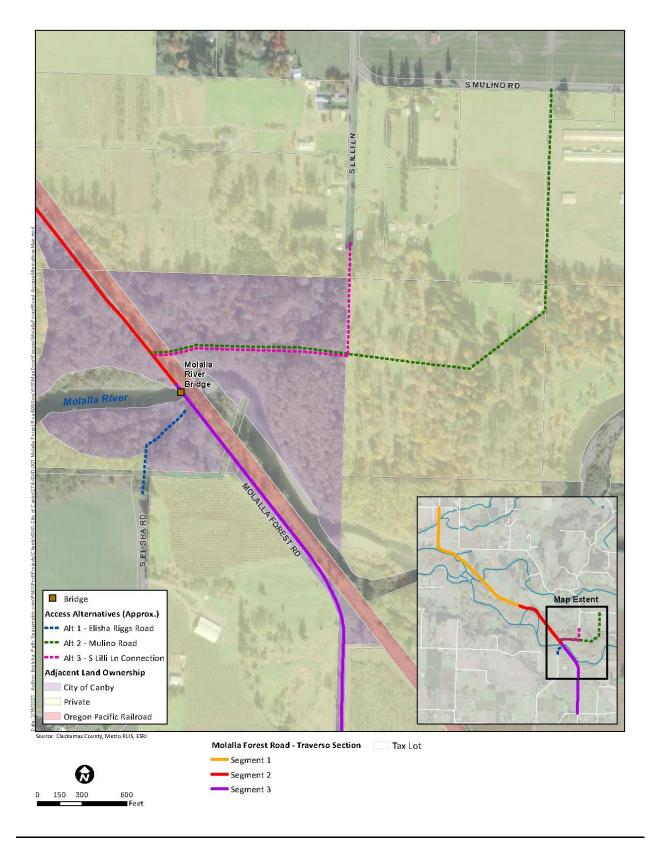
Figure 11. Mid-Point Access Alternatives

Given the access limitations at the north end, primary access to the trail could be achieved via S Elisha Road, which is located just south of the Molalla River Bridge and west of the MFR. Clackamas County currently owns the road right-of-way to the City property south of the bridge, which could be potentially developed into a small parking area.

An alternative access point to the trail could be achieved off S Mulino Road through private property. Access could be obtained via the private property located immediately to the south of S Mulino Road to provide access to the City of Canby—owned property just north of the Molalla River. Preliminary conversations with one of the property owners indicated they are open to discussions around the long-term purchase of their property for this purpose. This alternative would require a railroad easement, which may be very difficult to obtain.

Alternative access to the City of Canby property north of the Molalla River could be achieved via S Lilli Lane, which currently terminates at a juncture with private property; an easement through this property could provide a direct connection to the City of Canby property adjacent to the Molalla River. The private property located immediately to the east of the City of Canby property has also expressed openness to considering using part of their property for trail access

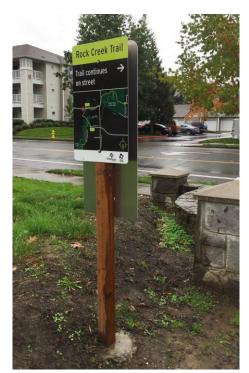
Figure 12. Examples of Trail Wayfinding and Educational Signage

Guidance on signing is available from several sources. The substantial Latino community in Canby means that many trail users may be Spanish-speakers and therefore, bilingual signage is desirable. The FHWA Manual on Uniform Traffic Control Devices (MUTCD) and the Oregon supplement provide guidance on regulatory and warning signs. Regulatory and warning signage needs to be closely coordinated with city, county, and ODOT standards. Signage should be consistent throughout the trail corridor, including the existing shared-use path in the City of Canby, to create a consistent brand and messaging to trail users throughout the entire corridor.

- Informational, Education and Interpretation –
 The setting of the Traverso Section lends itself
 to informational and educational signage
 opportunities that highlight the historic nature
 and uses of the road, the agricultural setting,
 and natural assets such as the Molalla River.
- Warning, Hazards, and Regulatory Signage warning users about trail hazards and conditions (e.g., "trail crossing ahead"). Also important is prominent signage that discourages users from straying from the trail and Traverso Section property (e.g., "no trespassing," "respect private property, please don't trespass"). Other regulatory signage includes providing information about trail rules (e.g., "no smoking or alcohol use on trail", "no river access," "no trespassing private property") (see Figure 13).

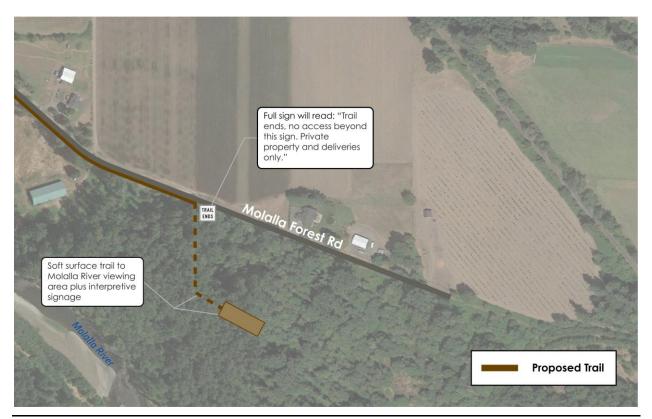
Figure 15. Potential Phase 1 Terminus

The goal of Phase 1 is to develop a useful and enjoyable segment of the trail that is low-cost and relatively uncomplicated to design and construct. Phase 1 would function as an extension of the existing Logging Road Trail in Canby from SE 13th Avenue south to near the washout, and it would essentially develop most of Segment 1. Phase 1 would create 1.5 miles of trail, stopping before the washout area. At this location, the Traverso property includes a relatively large (approximately 9-acre) triangle-shaped parcel that extends to near the Molalla River. Phase 1 could include development of a soft-surface trail on this property that ends at small overlook of the Molalla River (see Figure 15). This would provide a destination for trail users and a natural turnaround point until the trail is extended farther south. River access would not be permitted.

- Development of signage (wayfinding, regulatory, hazards, etc.)
- Trail fencing
- Trash receptacles and a pet station at the intersection of SE 13th Ave, off of the existing Logging Road Trail. This location would be visible to help deter illegal use and if placed on the existing Logging Road Trail, would limit access to just those using the trail.
